Confidential Inspection Report

LOCATED AT:
5555 Inspection Lane
City, Michigan 55555

INSPECTED ON:
Saturday, January 11, 2020

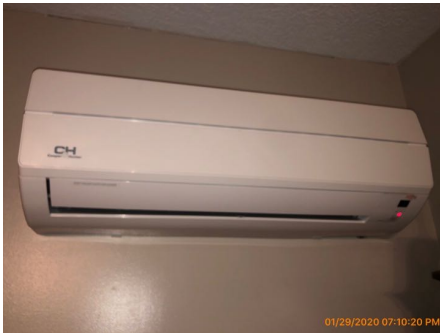
Space Heater

2: Space heaters vary in configuration and operation, but are generally installed to heat only the area they occupy. Important elements include the heat exchanger, exhaust venting, controls, and clearances from combustible material.

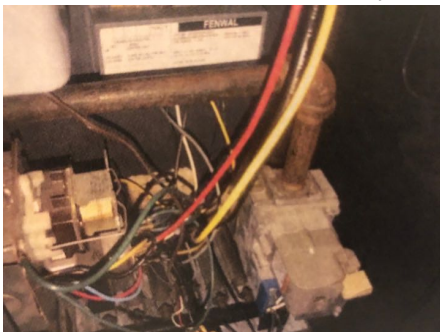
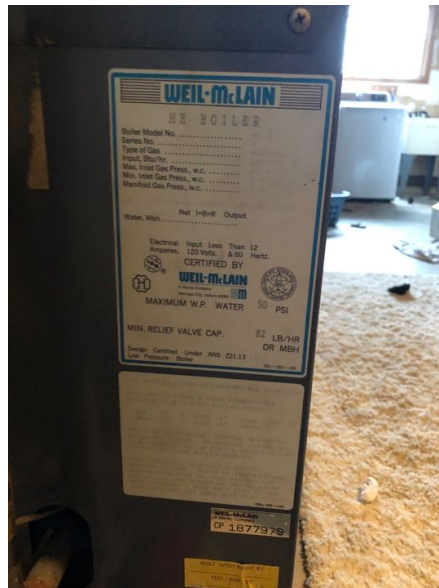
BOILER

3: The boiler responded to normal operating controls. Components appear to be properly installed and serviceable. This is an older system showing normal wear and tear, but we noted no conditions considered out of the ordinary.

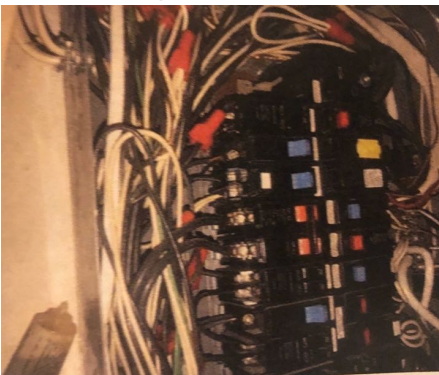
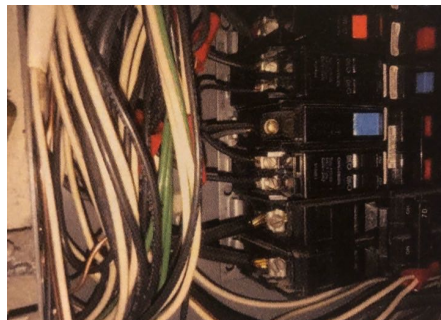
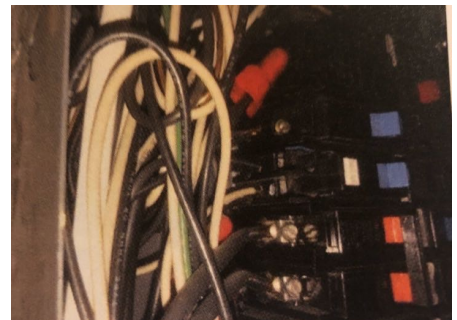
MAIN CIRCUITRY

- 8:** We found over-fusing in the main service panel, meaning breakers or fuses are not rated for their connected wires. This is a potential fire hazard. We recommend circuits be equipped with properly rated overcurrent protection devices.

- 9:** Multiple wires are installed on individual terminals. This 'double lugging' is not permitted because positive connection for all wires is not assured. We recommend reconfiguration of the circuitry so that each wire connects to only one terminal.

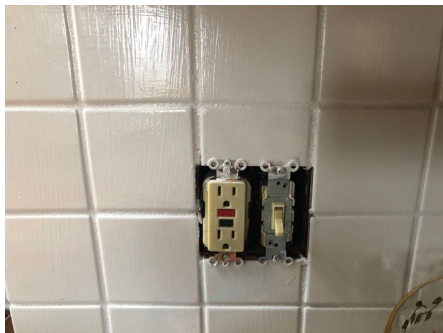
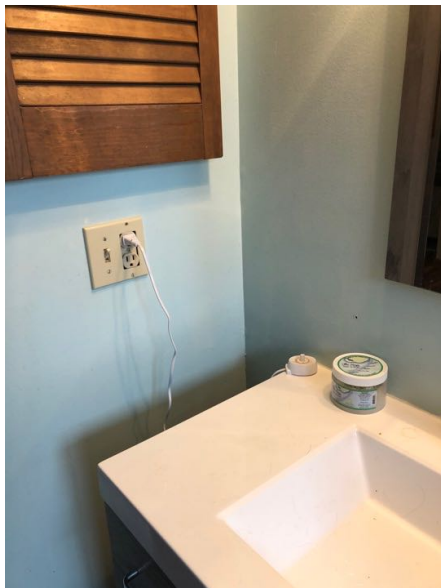
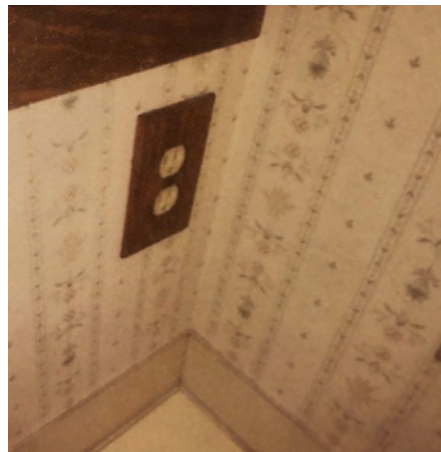
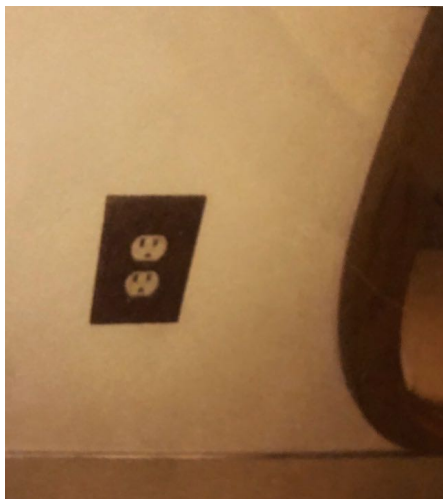
GFI PROTECTION

11: No GFCI protection is installed. We recommend upgrading by installing ground fault receptacles in all locations required by present standards. These include receptacles near sink basins, in bathrooms, garages, crawl spaces, and the exterior.

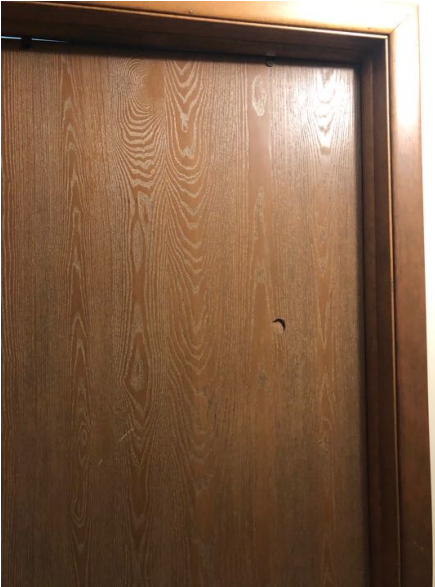
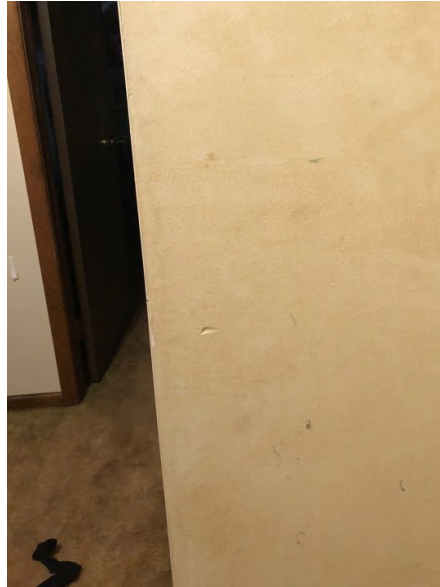
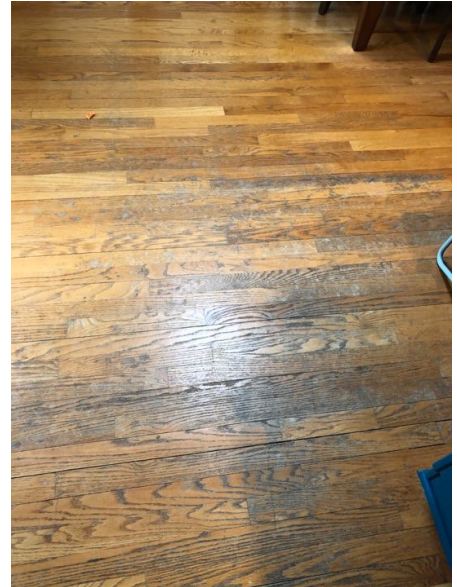
SURFACES: OVERALL

12: There is wear and tear throughout the house, of the type generally resulting from age and heavy use. We make no attempt to list all cosmetic flaws and suggest that most of these deficiencies will be addressed by routine maintenance and upgrading.

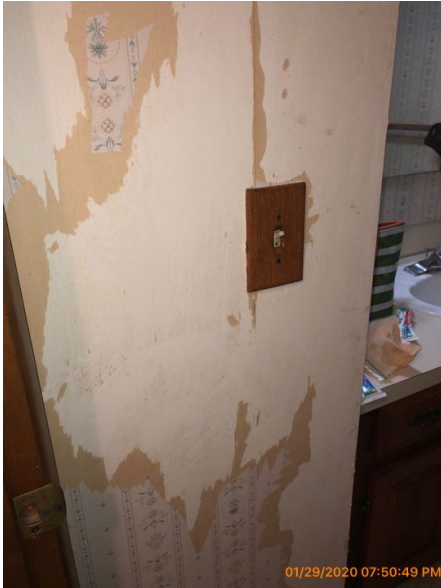
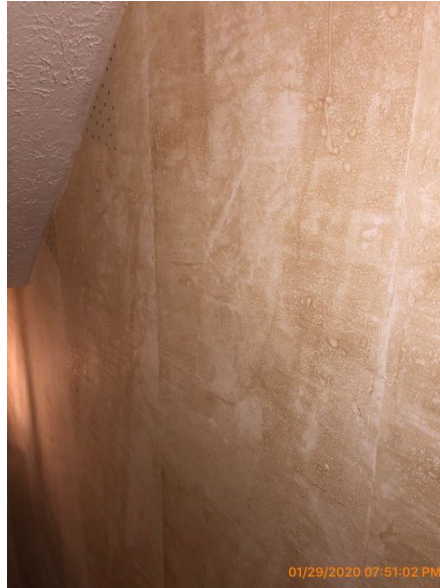
WALLS & CEILINGS

13: The interior wall and ceiling blemishes are cosmetic and can be repaired in the course of routine maintenance.

14: There are minor cracks in the walls and/or ceilings. This is a common condition with this type of construction and does not indicate a structural deficiency. The cracks can be repaired or painted over during routine maintenance.

15: The interior walls and ceilings exhibit many years of use with little or no attention to cleaning or maintenance. For an improved appearance, they should be professionally cleaned, prepared and refinished.

16: For attention to the condition(s) noted above, and/or cost estimates, if necessary, we recommend the advice and services of a licensed painting contractor.

17: For attention to the condition(s) noted above, and/or cost estimates, if necessary, we recommend the advice and services of a licensed general contractor.

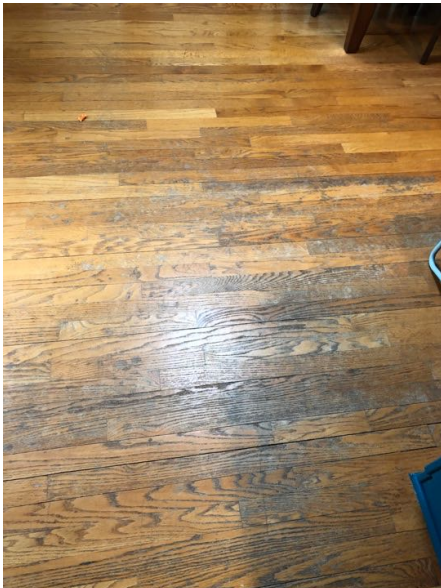
FLOORS: OVERALL

18: There are cosmetic floor blemishes which can be eliminated in the course of routine maintenance.

19: Portions of the floors are worn. We recommend refinishing to protect the wood and for a better appearance.

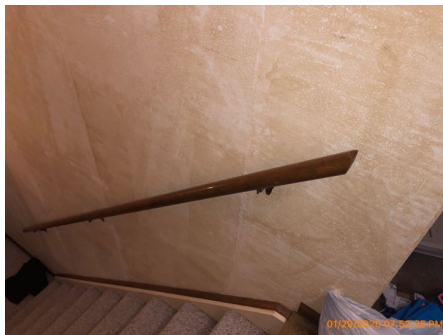
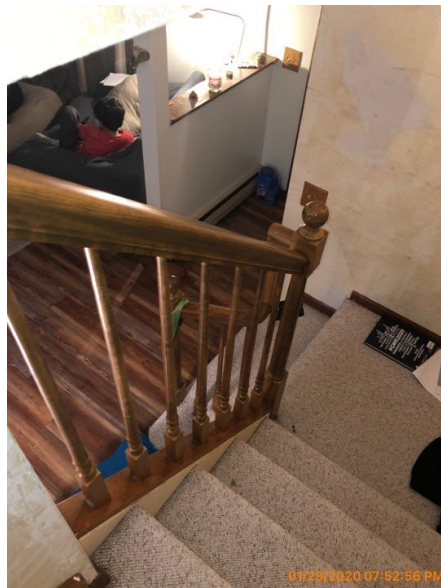
STAIRS

20: The stairs were used several times during the inspection. The various components appear to be properly installed and no deficiencies were noted during use. The handrails were securely attached.

21: The railings appear to properly installed and are in serviceable condition.

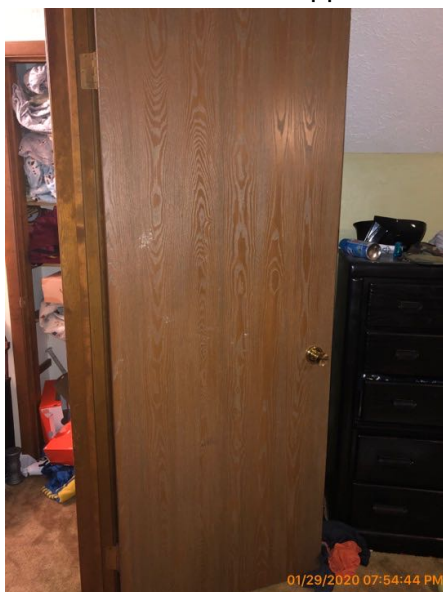
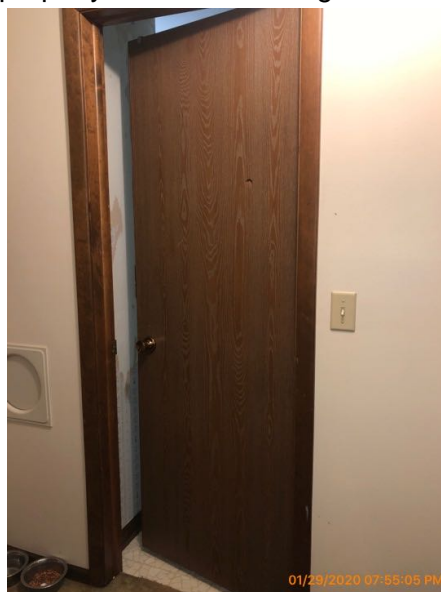
DOORS: OVERALL

22: The interior doors appear to be properly installed and in good condition.

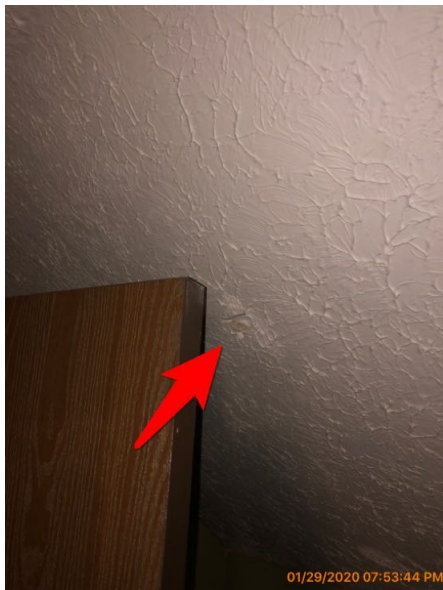
23: The interior doors appear to be properly installed and in good condition, with the exception of the door at the {FillHere}. Attention to this door is recommended.

24: Several of the doors are missing their door stops. This condition will lead to damage of the wall surfaces. We recommend door stops be installed where needed.

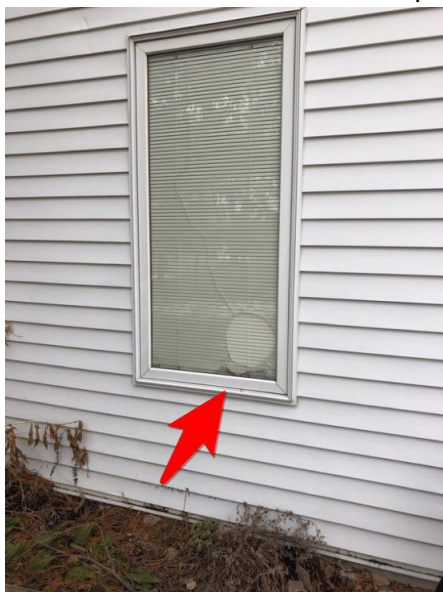
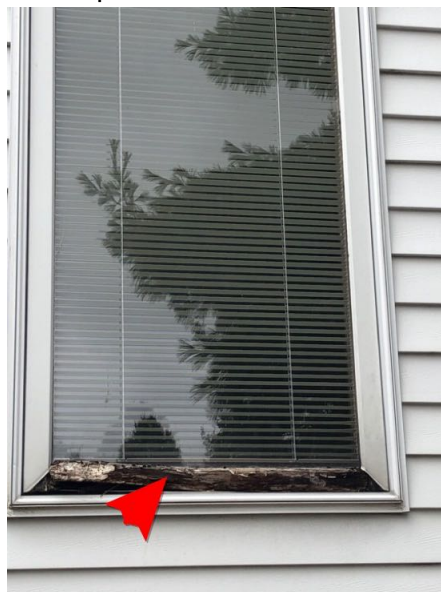
WINDOWS: OVERALL

25: We operate a representative sample of the windows, but do not necessarily open, close, and latch every window. Our inspection standards require testing a minimum of one window in every room.

26: There is broken and/or missing hardware (latches, cranks, etc.) on a number of the windows. We recommend the hardware be repaired or replaced.

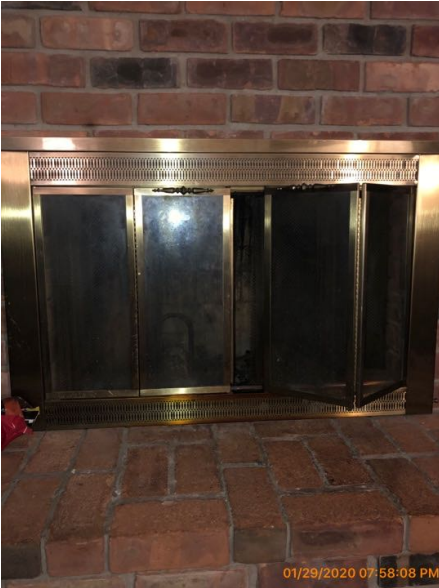
FIREPLACE

28: The fireplace appears to be properly installed and in serviceable condition with no signs of excessive or unusual wear.

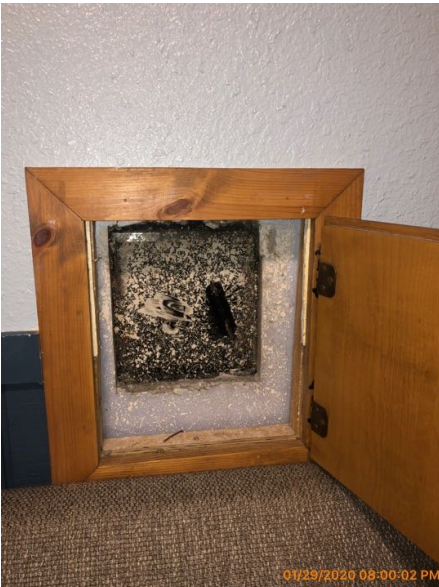
29: Minor cracks and/or erosion are normal and should not be a concern unless or until the bricks become deeply eroded or loose.

30: The fireplace does not have a damper. The glass doors across the fireplace may be used in lieu of a damper to minimize interior heat loss when the fireplace is not in use.

31: We were not able to fully evaluate the fireplace and chimney because of the build-up of soot and/or creosote. We recommend the flue be cleaned and that further inspection be accomplished prior to the close of escrow.

32: For attention to the condition(s) noted above, and/or cost estimates, if necessary, we recommend the advice and services of a licensed general contractor.

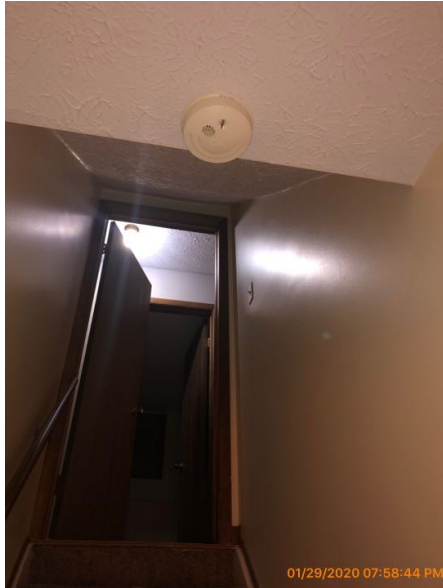
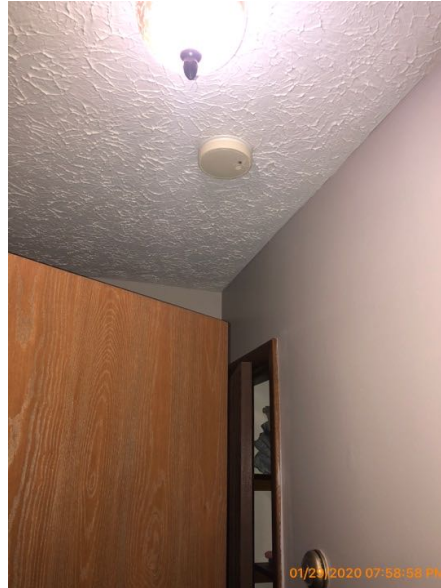
DETECTORS: OVERALL

33: The smoke detectors were tested with their test buttons. This method only verifies battery and horn function, but does not test the sensor in the unit. After occupancy, and regularly thereafter, we advise testing with real or simulated smoke.

34: The smoke detectors are appropriately located.

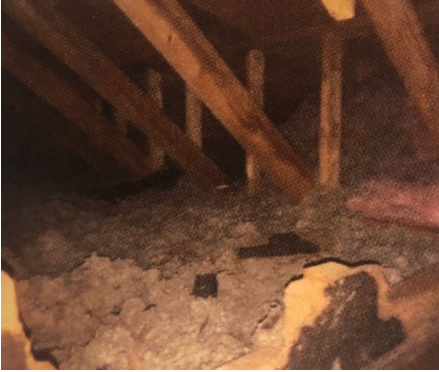
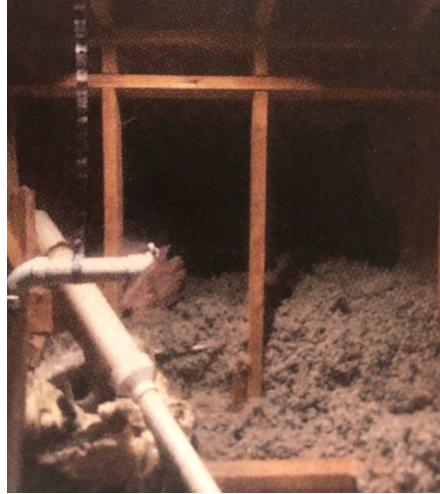
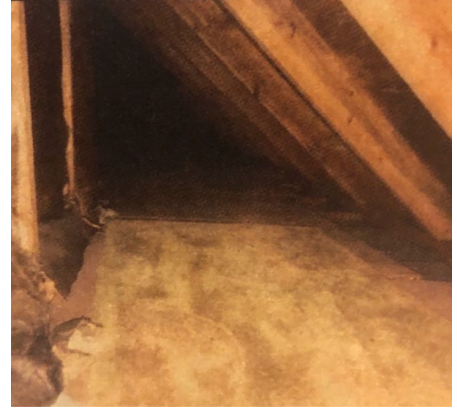
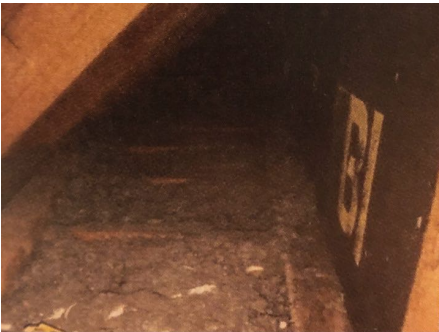
ATTIC INSULATION

35: The attic has blown-in fiberglass insulation.

36: The insulation is installed in a substandard manner. We recommend it be reworked or replaced in accordance with accepted standards.

37: The insulation has settled and no longer provides the same R-value as when it was installed. We recommend additional insulation to increase energy efficiency.

38: There is missing or loose insulation in the attic. We recommend it be replaced and/or restored to its original configuration.

39: For attention to the condition(s) noted above, and/or cost estimates, if necessary, we recommend the advice and services of a licensed general contractor.

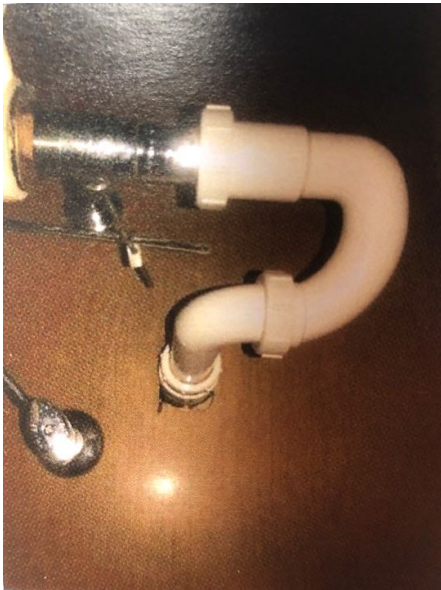
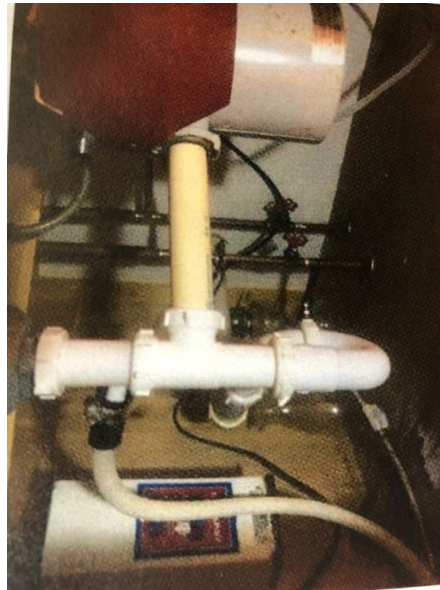
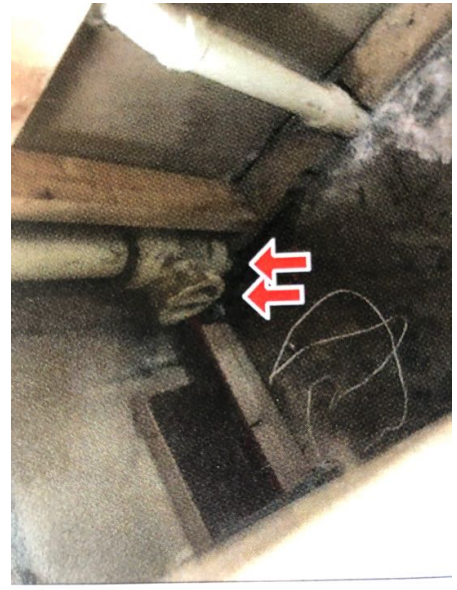
INTERIOR SUPPLY

40: There was evidence of surface corrosion and past leakage at the exposed and accessible supply piping. Although no current leaks were noted, this piping should be monitored for leakage and repaired if necessary.

41: For attention to the condition(s) noted above, we recommend the advice and services of a licensed plumbing contractor.

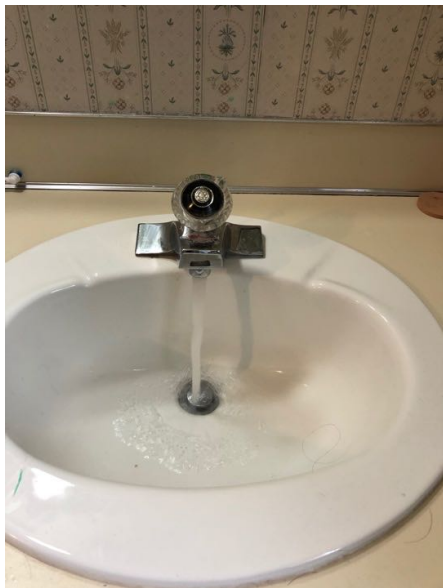
WATER PRESSURE

42: The system water flow drops excessively when tested during use, suggesting a buildup of mineral deposits on the interior of the supply piping. This is common in older systems and does not necessarily require immediate repair.

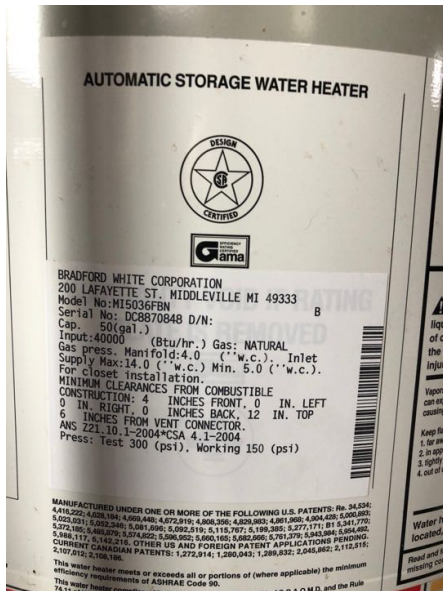
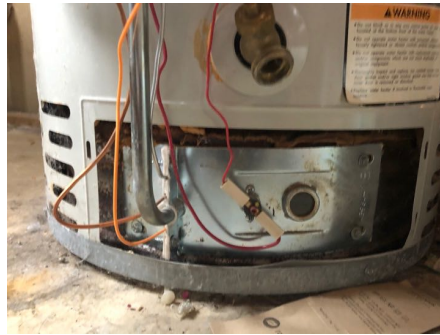
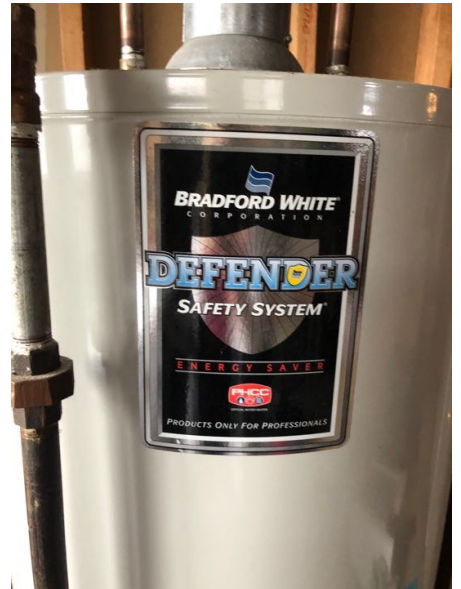
44: Location: In the basement

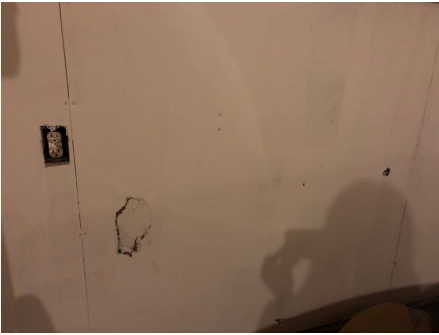
WALLS

49: The walls are drywall.

50: The wall surfaces are blemished, and can be repaired in the course of routine maintenance.

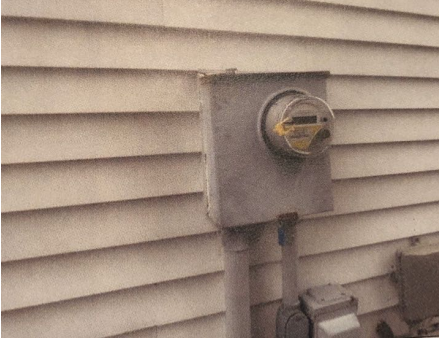
METER & MAIN

1: The meter and main electrical service panel are located underground.
